No More Heads or Tails The Adoption of Welding in U.S. Navy Submarines DAVID L. JOHNSTON

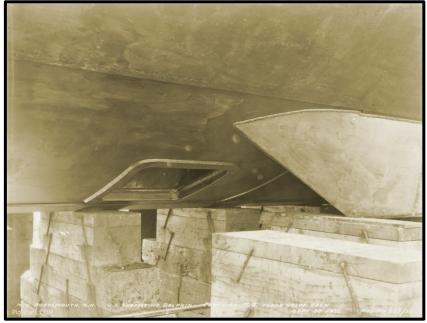
Figure 7. View of Dolphin's keel area, showing welded flood port flange and welded bilge keel. (NARA photo courtesy Roger Torgerson and PigBoats.COM)

Fig. 7 shows a view of Dolphin's port side near the keel, aft of the bow and looking aft and to starboard. The square opening in the outer hull is a flood port for a ballast tank. main The triangular object attached to the hull is the boat's port side bilge keel, a stability device that is intended to reduce wave-induced rolling while on the surface. Along the edges around the flange for the flood port and on the edges of the bilge keel where it attaches to the hull, a welding bead can clearly be seen.

Remarkably, the outer hull plating seam directly above the bilge keel displays the distinct round heads of rivets. The *Dolphin*, built at Portsmouth, preceded the construction of the *Cuttlefish* at Electric Boat by a full year. The undeniable presence of welding on a submarine that has long been listed as being of fully-riveted construction surprised both of us. This revelation prompted a review

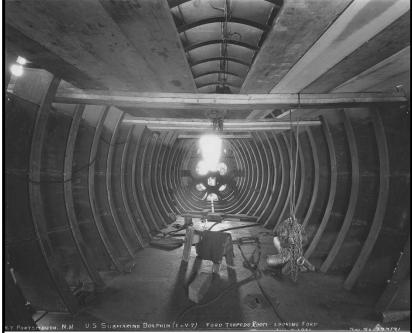
Recently, Hedman came across another photograph that gave us further confirmation (Fig. 8). This photo shows the *Dolphin's* forward torpedo room while she was under construction at Portsmouth in 1931. This is a very early stage of the construction process with just the basic framework and tankage completed. The four torpedo tubes that make up the forward portion of her main armament have yet to be installed. If you look closely in

Figure 8. Dolphin forward torpedo room while under construction at Portsmouth, 1931. (NARA College Park photo courtesy of Tracey White and Navsource.com)
