A VISUAL GUIDE TO THE S-CLASS SUBMARINES  
1918-1945  
PART 2: THE GOVERNMENT BOATS  
(5th Edition, February 2023)

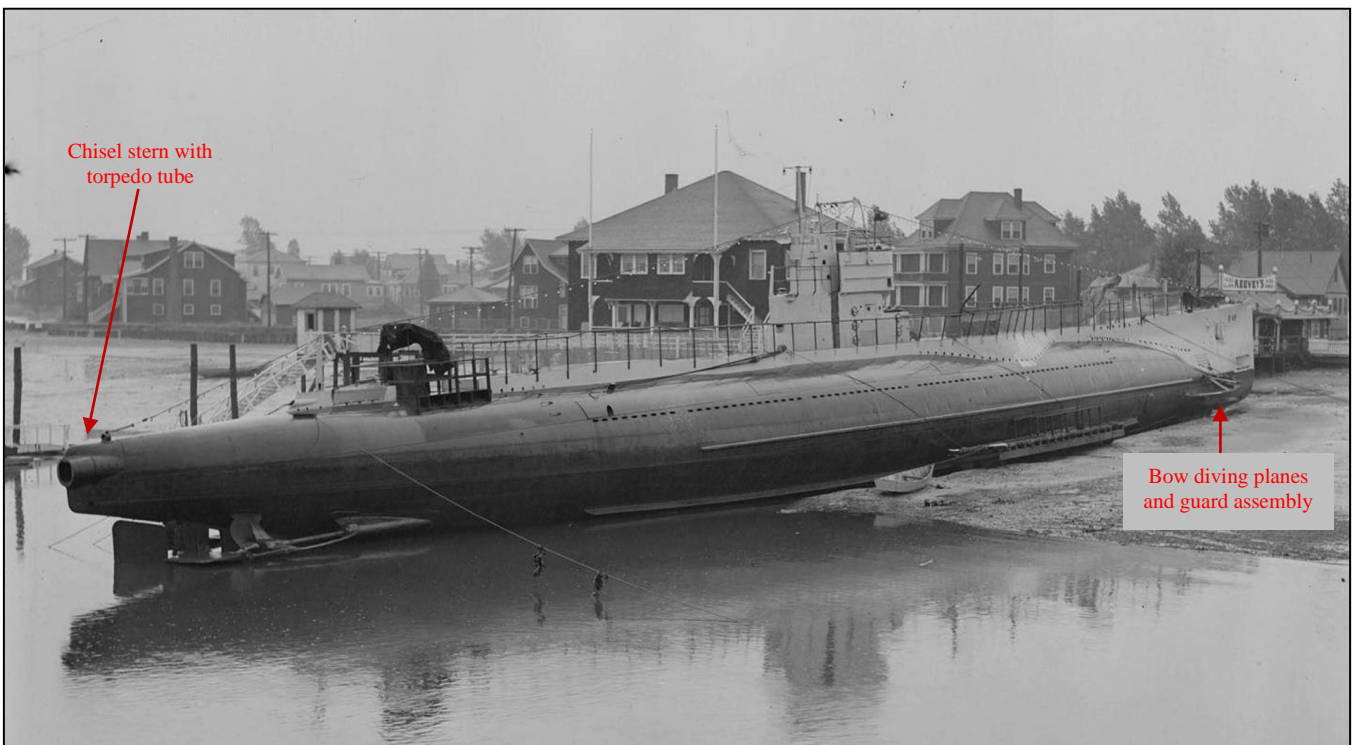
Fig. 16. S-49 beached in Revere, Mass. as a tourist exhibit in 1935. NARA photo via PigBoats.COM.

Figure 16 shows *S-49* after being decommissioned, beached as a tourist exhibit in Revere, Massachusetts in 1935. It is a good shot of the hull below the waterline. On the far left the configuration of the chisel stern and torpedo tube can be seen, and it is apparent how it differed from the *S-10* group. On the right the bow diving planes and plane guard are visible. The small wooden structure on the aft deck is an access point cut into the motor room after the boat had been sold to a civilian interest. It was not part of her operational configuration.
